POTENTIAL HAZARDOUS WASTE SITE

EXECUTIVE SUMMARY *Preliminary Assessment*

Republic Steel Corporation
Site Name

Date of Site Visit: 9/30/83

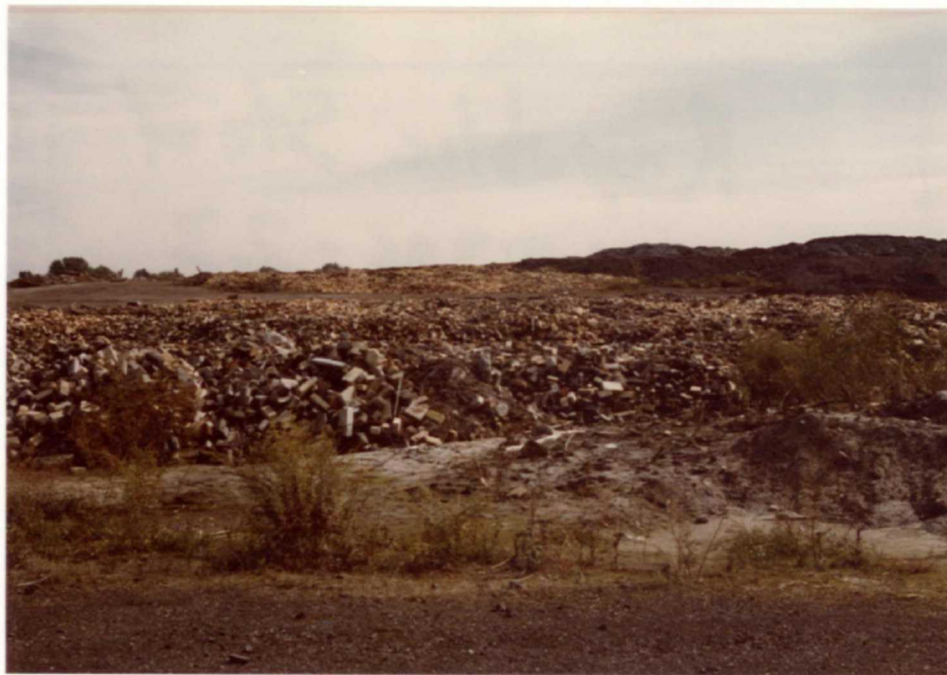
1. Piles of checker brick and slag covering the former limestone pit.

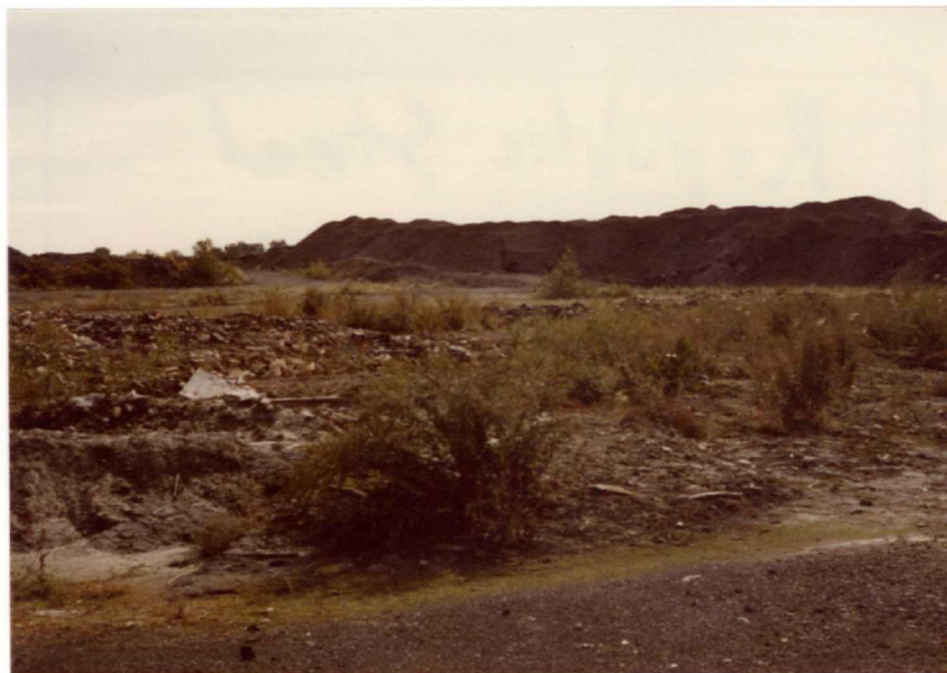
2. View southeast to large slag pile.

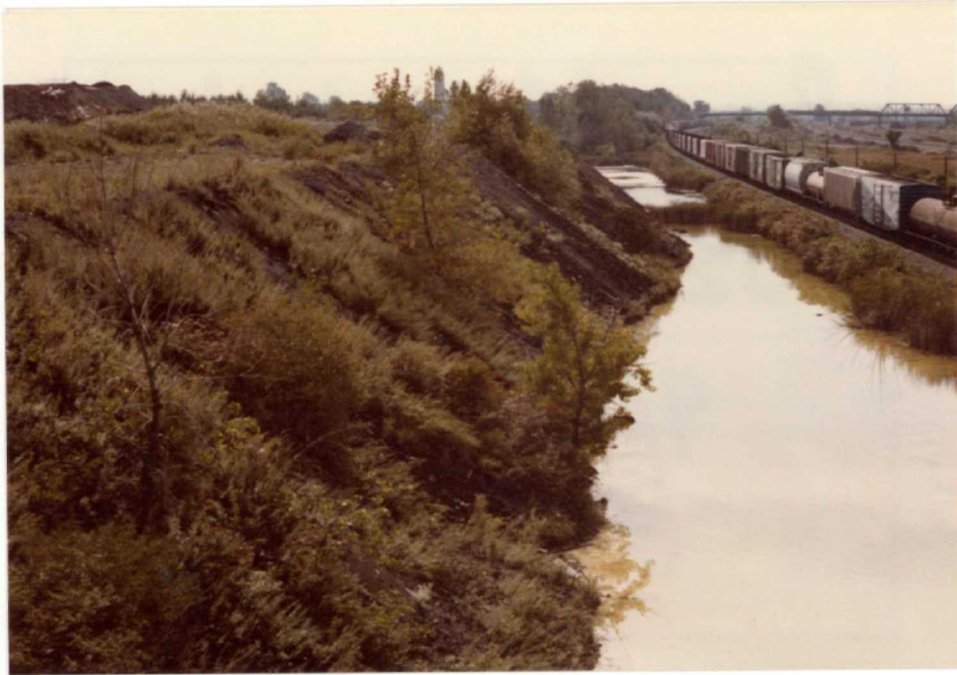
3. Looking south from railroad trestle at the water channel adjacent to the west boundary of the site.

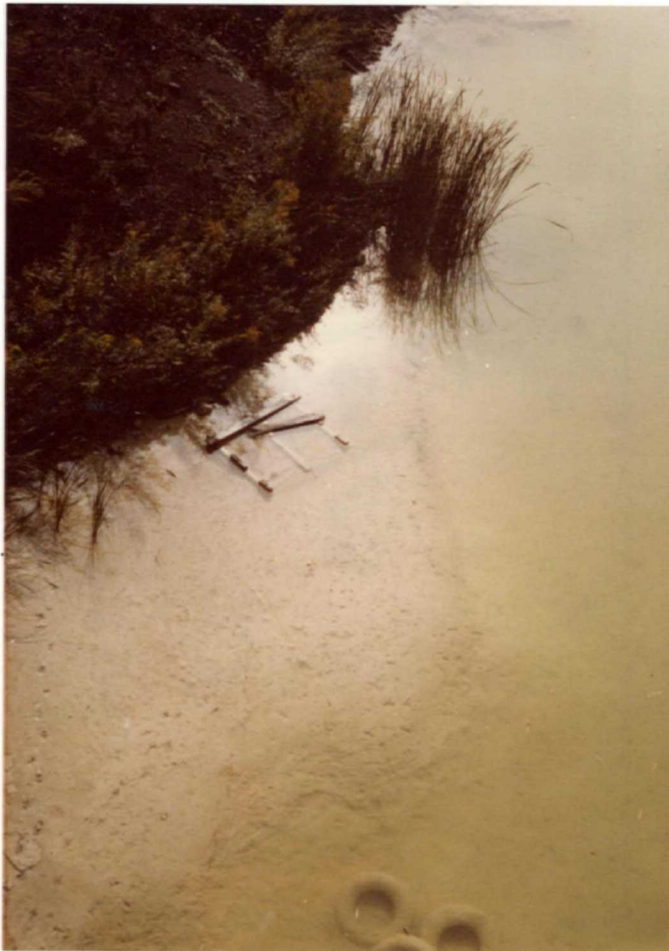
A water channel adjacent to the west boundary of the site is contaminated with carbonates formed in the reaction of waste pickle liquor and limestone used for treatment on site, according to Mr. Gubanc, the site representative.

4. Carbonate products in water channel from lagoon-type treatment of acid on-site.

The adjacent surface water body and monitoring well should be sampled for priority pollutants and PCBs.

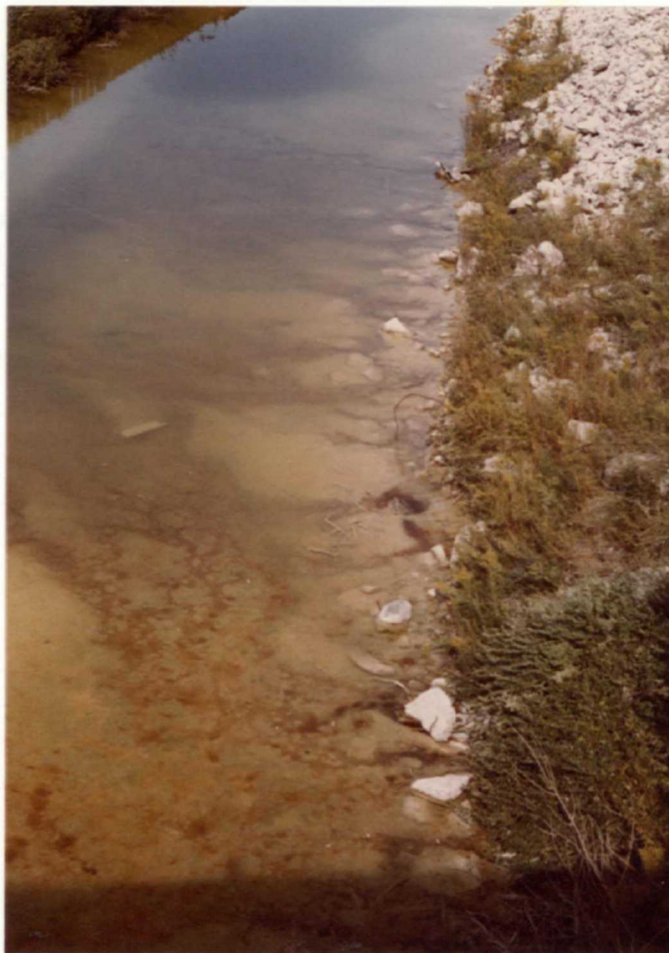
Upon termination of acid disposal on site in 1979, the impoundment was packed with limestone and covered. However, during the 15 years the impoundment was used, a carbonate product of the reaction has leached into the water channel adjacent, west.

5. Northerly view from railroad trestle of active leaching into water channel.

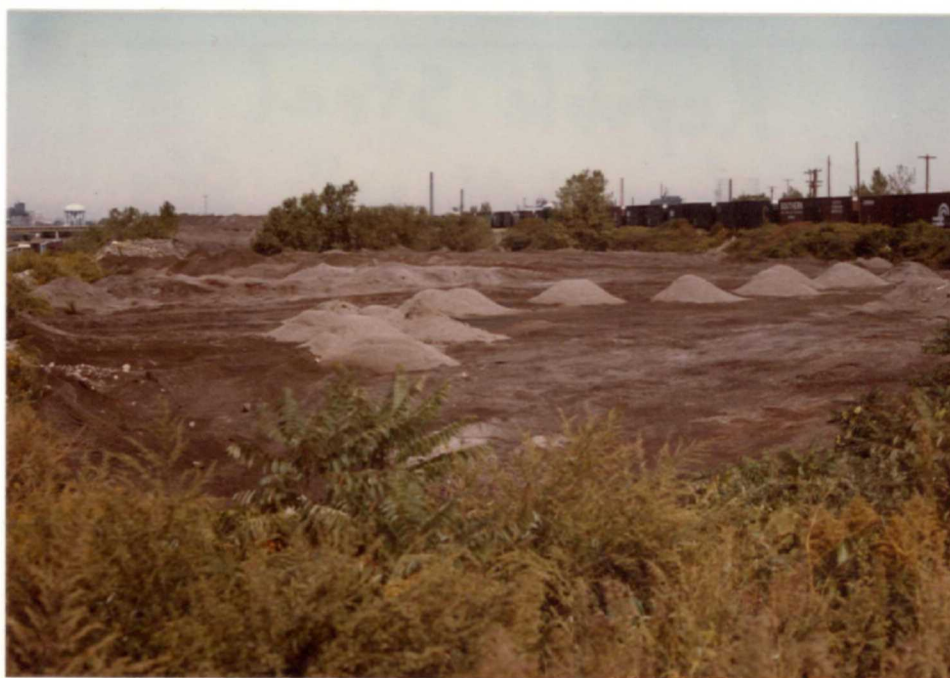
6. Small piles of blast furnace flue dust.

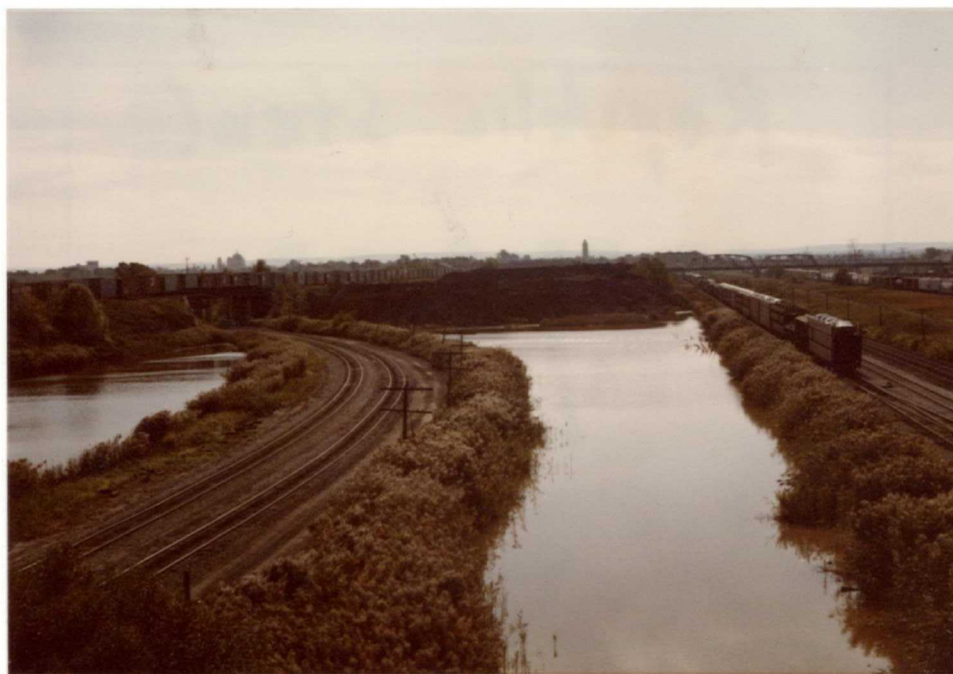
7. Northern tip of landfill as seen from Tifft Street bridge.
